# MDS-MX1

# SONY. SERVICE MANUAL

# **SUPPLEMENT-1**

**Subject: 1. CORRECTION**

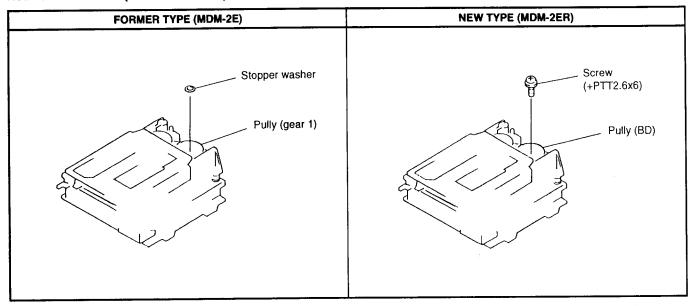
#### How to discriminate (Mechanism deck)

The mechanism deck has been changed from MDM-2E to MDM-2ER.

Refer to How to discriminate (Mechanism deck) so that there is no interchangeability between MDM-2E and MDM-2ER.
