# MDS-MX1

# SONY. SERVICE MANUAL

# **SUPPLEMENT-1**

**Subject: 1. CORRECTION**

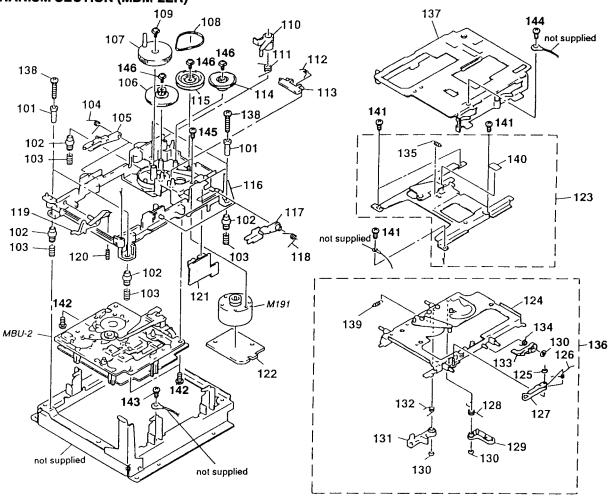
### **MECHANISM SECTION (MDM-2ER)**

## 4. CHANGE OF MECHANISM DECK

The mechanism deck has been changed from MDM-2E to MDM-2ER.
